# SUSTAINABLE FISHERIES MANAGEMENT PROJECT (SFMP)

## Shama Disaster Management Committee Meeting and Field Work To Plan Anlo Beach Resettlement

April, 2016

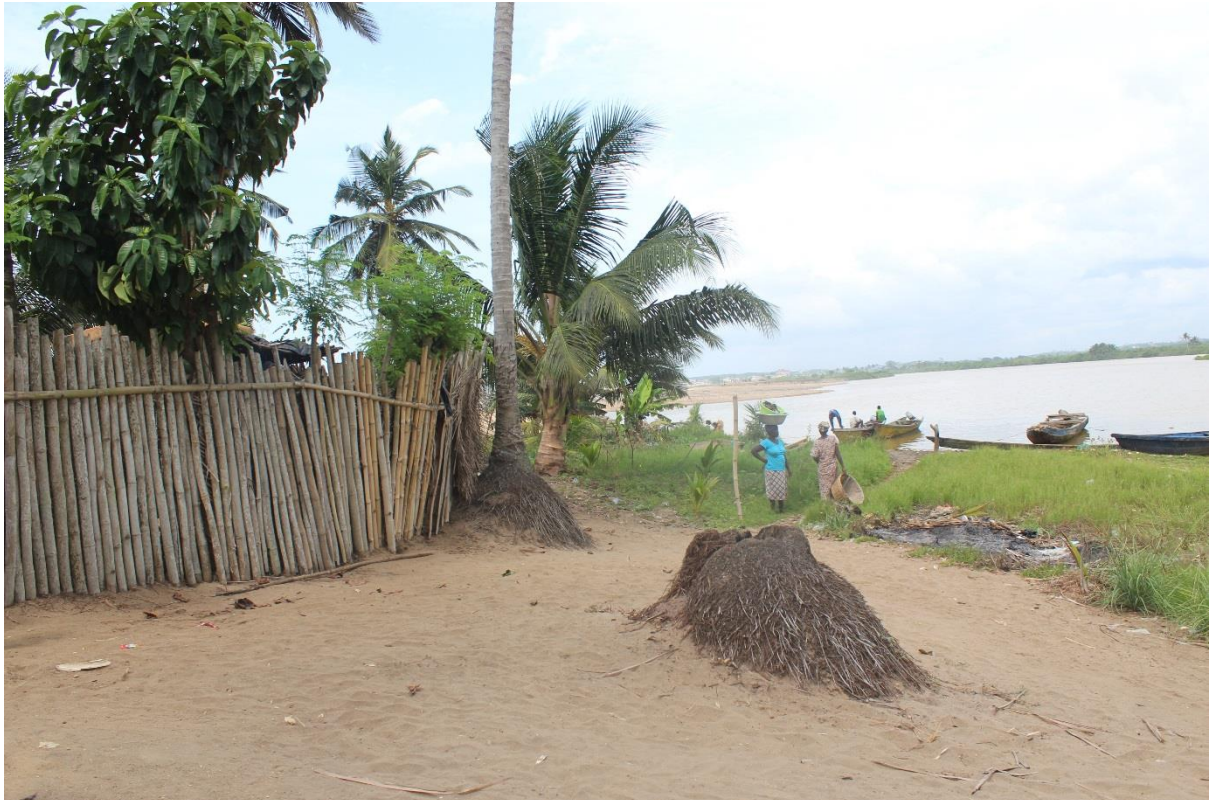
The rapid assessment revealed about 146 houses that are so close to the banks of the Pra River and/or the shore of the sea. These were noted to be highly exposed to the threats of coastal erosion and riverine flooding (Figure 4). However, there were some uncounted houses which stand the chance of been threatened once the highly exposed ones are washed off or eroded. Some other houses which were noted to be extremely vulnerable to flood whether or not there is incidence of rainfall or coastal splashes were excluded from this assessment since they lie on the other side of the river close to Old Shama, known as 'Anwona Kwesi'. The counting also excluded houses that had already collapsed or suffered from the adverse effects coastal erosion and or flooding (Figures 5 and 6).

**Figure 4 showing structure which is very close to river Pra and exposed to flooding**

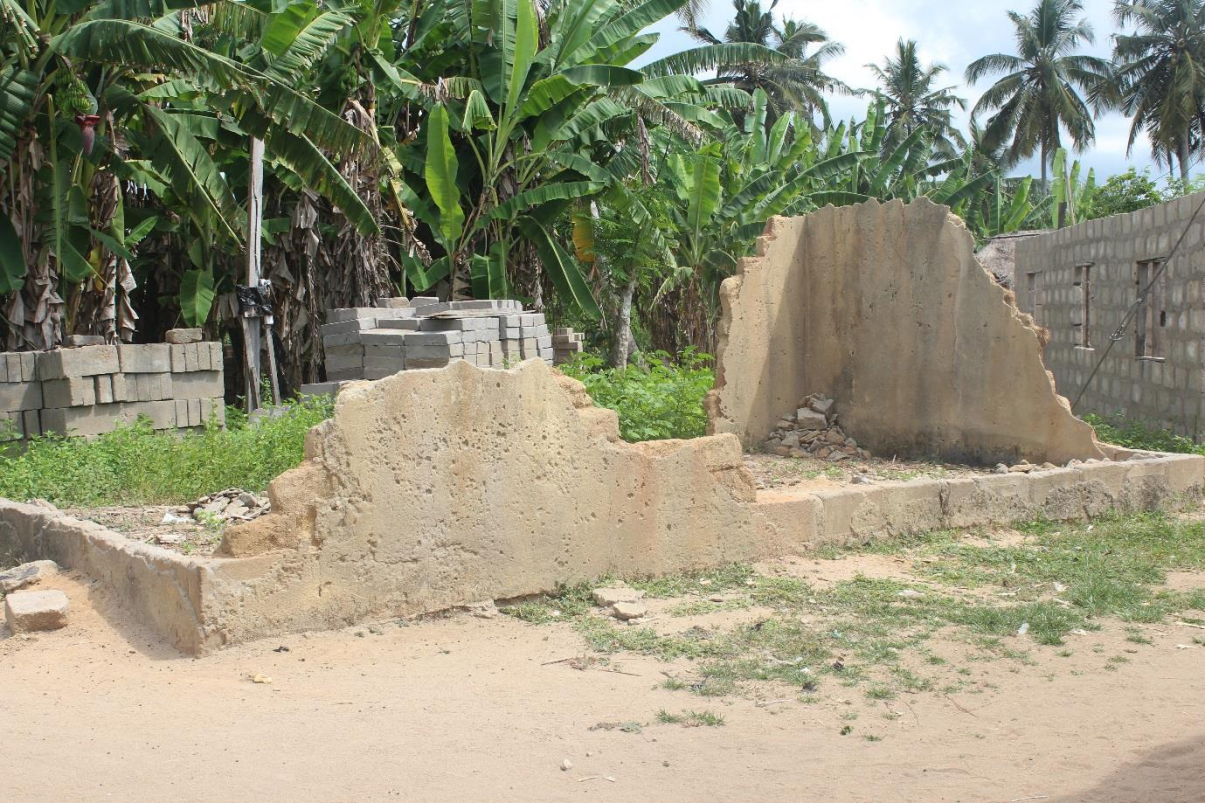
**Figure 5 A collapsed structure due to effects of coastal erosion**

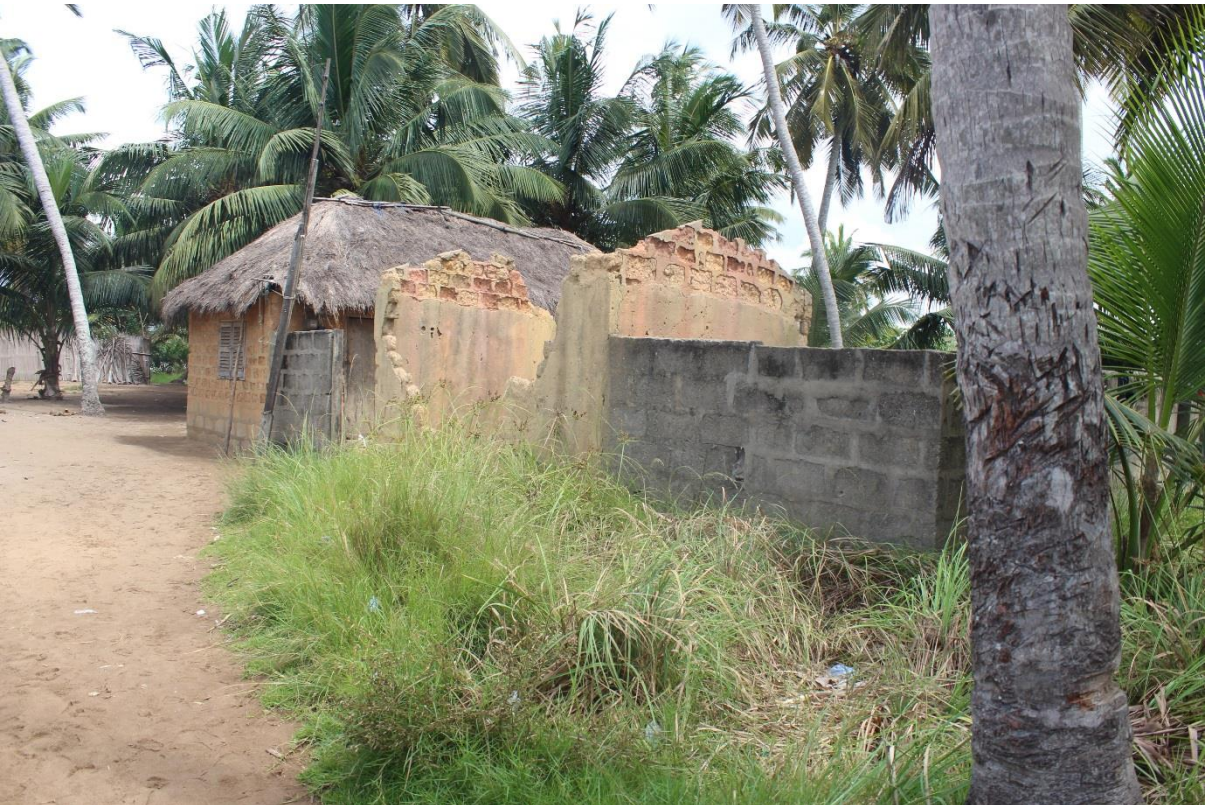
**Figure 6 A collapsed structure due to effects of flooding**

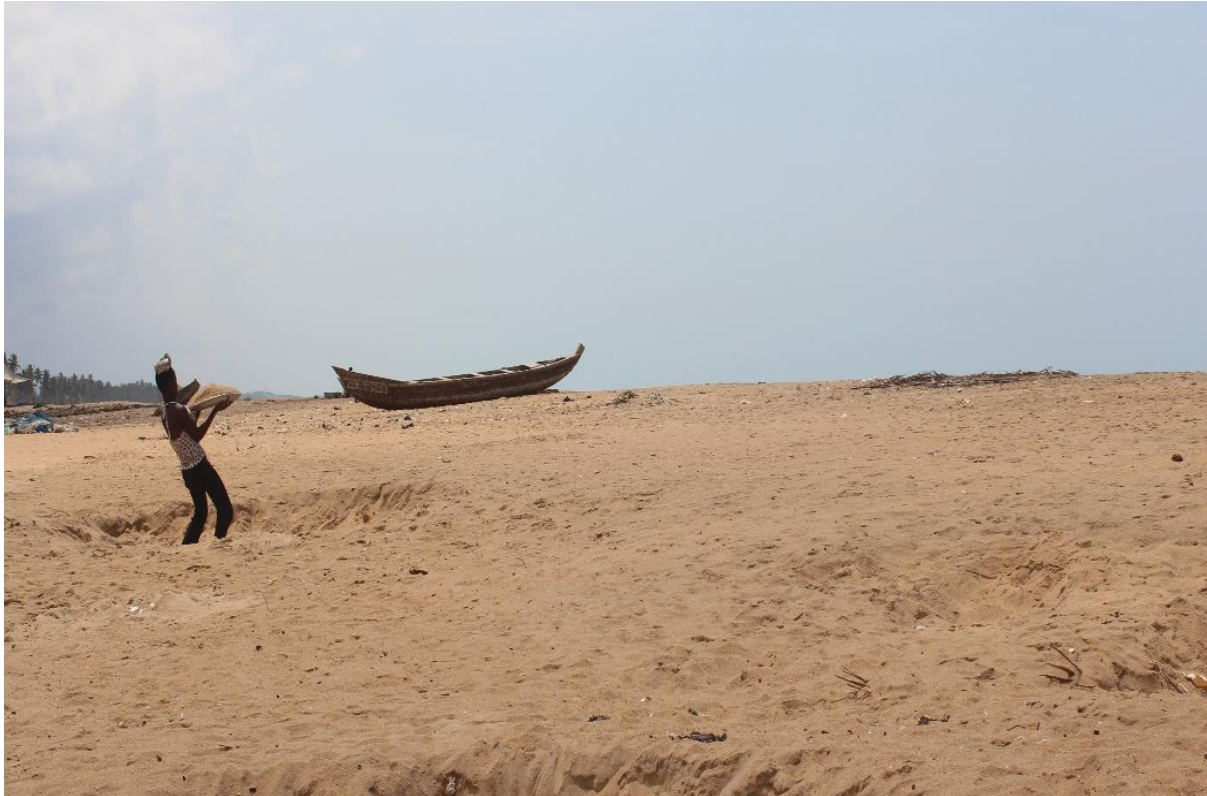
The identified houses were either made of Sandcrete, Mud, Bricks, or Mud bricks. These are built with wined beach sands (Figure 7) which increases the extent to sea erosion. Others were also made with bamboos and mangrove trees (Figure 8). They were either roofed with Asbestos, Thatches or Aluminum. Averagely, the houses have 4 to 5 rooms, with about 6 to 7 average occupants. GPS devices were used to pick exact locations of the various houses and structures. Details of all the identified households are in Table 2.

**Figure 7 Beach Sand being wined (excavated) for building**

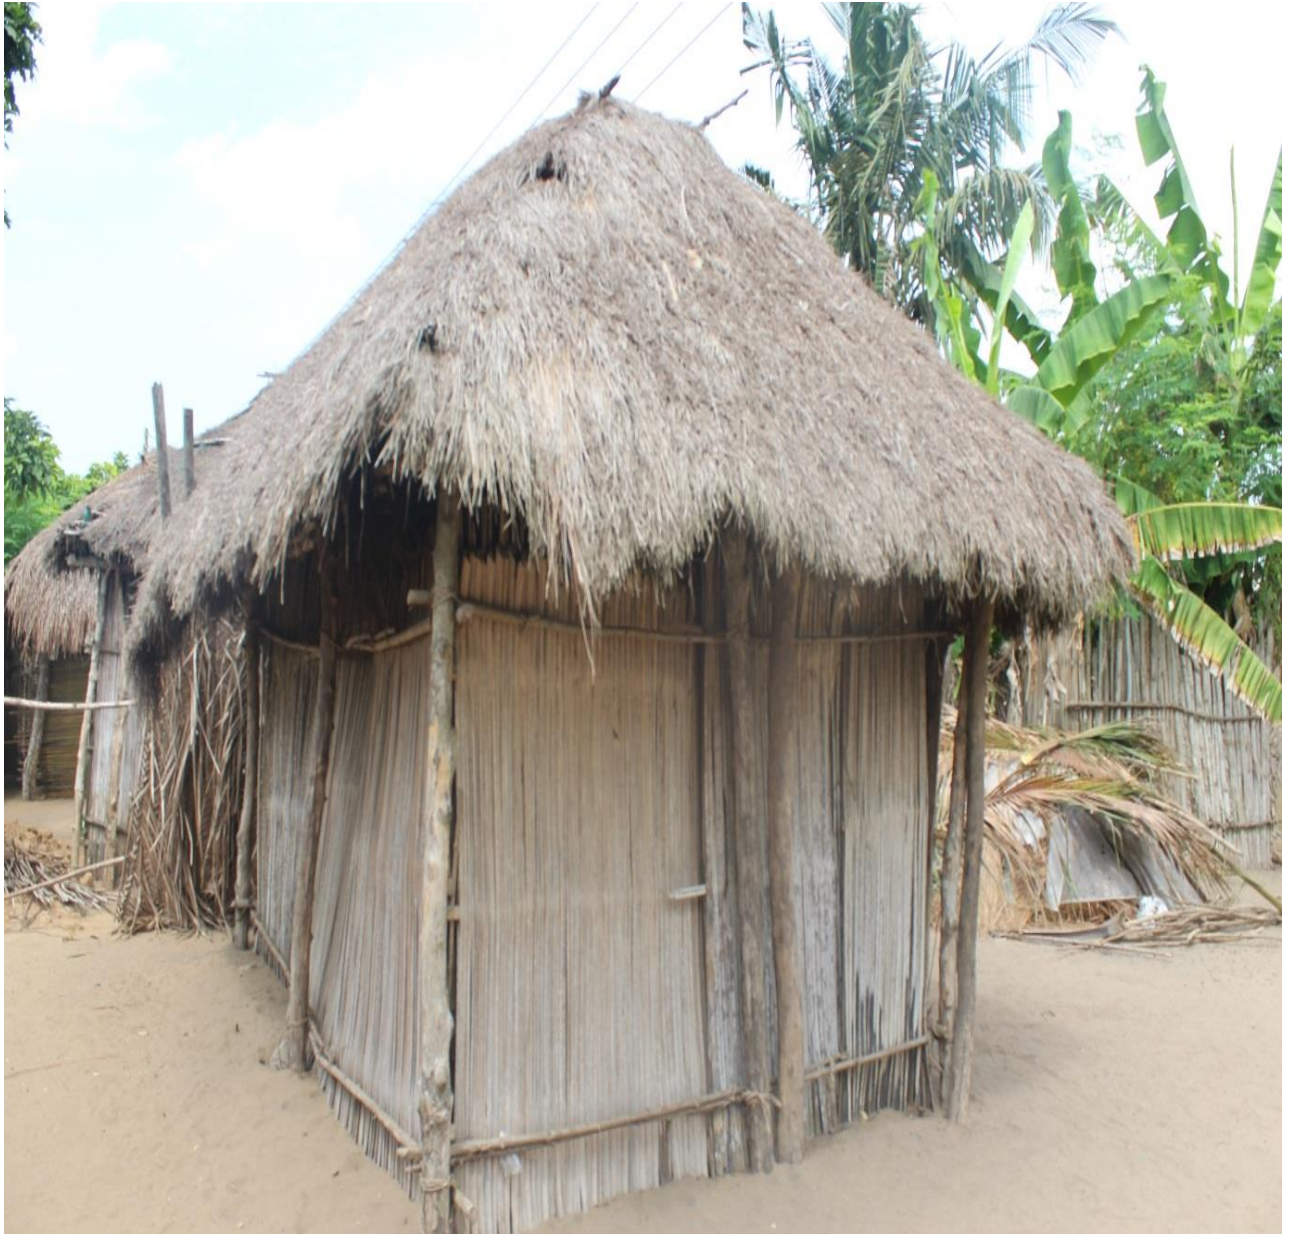
**Figure 8 A structure built with bamboos and mangrove trees**
