SUSTAINABLE FISHERIES MANAGEMENT PROJECT (SFMP)

Analysis of Spatial Planning Options: Ankobra

September 2015

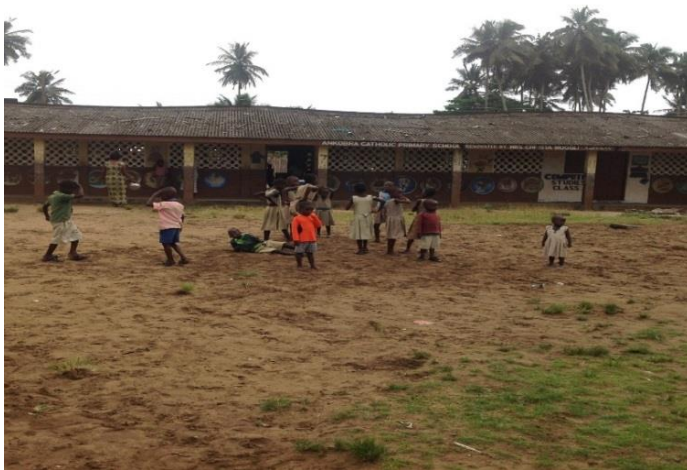
Plate 3 Primary School at Sawoma

The most social amenities needed in all communities are education and health facilities yet they are lacking. Out of the ten settlements four have basic (primary) education facilities. The only communities with Junior High Schools (JHS) are Sanwoma, Kukoavile and Adelekazo. Though some of the schools' physical structures appear strong, majority of them are in dilapidated state as shown in pictures below.

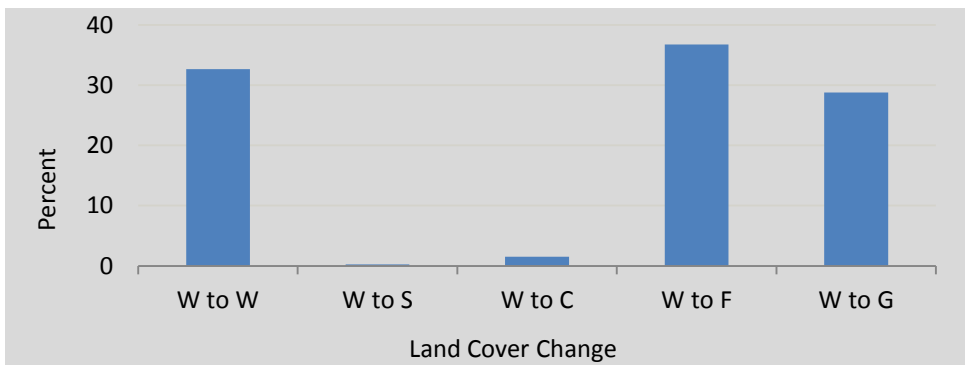
Figure 10 Wetland Change in Study Area, 1990 – 2010

Having established the fast rate of depletion of wetlands, this section examines the details of the depletion as to which land cover type is absorbing what quantum. About two thirds (3 km²) of wetlands in 1990 were taken over by other land types during the 20 year period as shown by figure 3.8. Perhaps a consolation for the diminishing wetlands is that more than a third (37 percent) of the loss was to forestlands which also represent a vital component of the ecosystem.

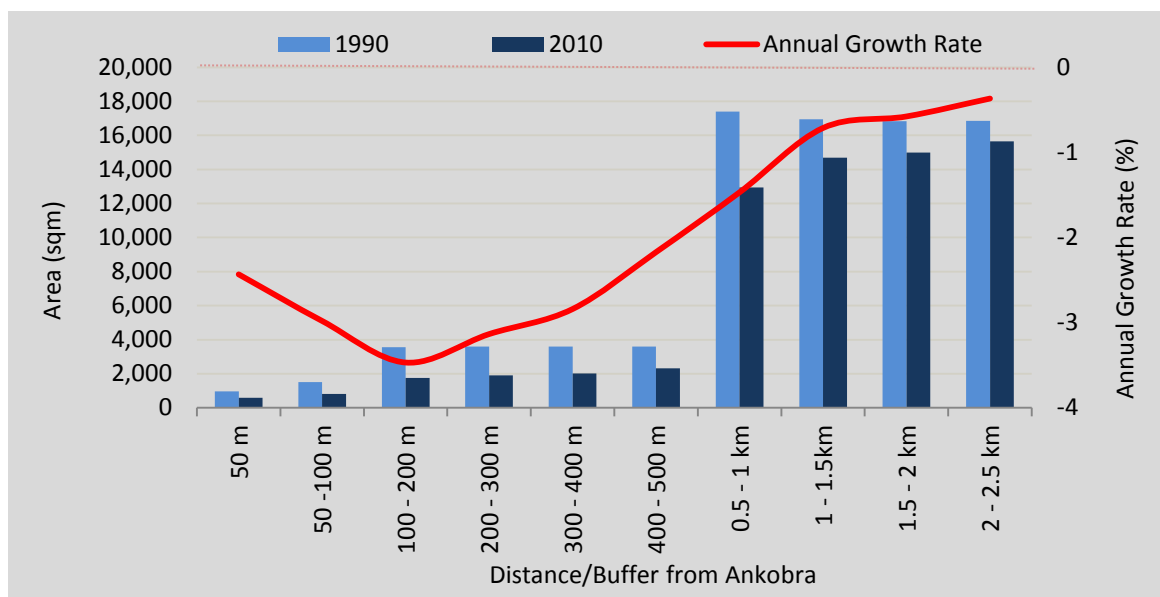
Figure 12 Forest Cover Change and Distance from Ankobra River

As earlier identified, there was a decline in forestland in both the 50 meter buffer and the entire study area. This section examines in detail the dynamics of forest cover change and distance from Ankobra River. From figure 3.10, for all distances considered, forest cover loss is observed. What differs among the distances (buffer rings) is the extent of forest cover depreciation.

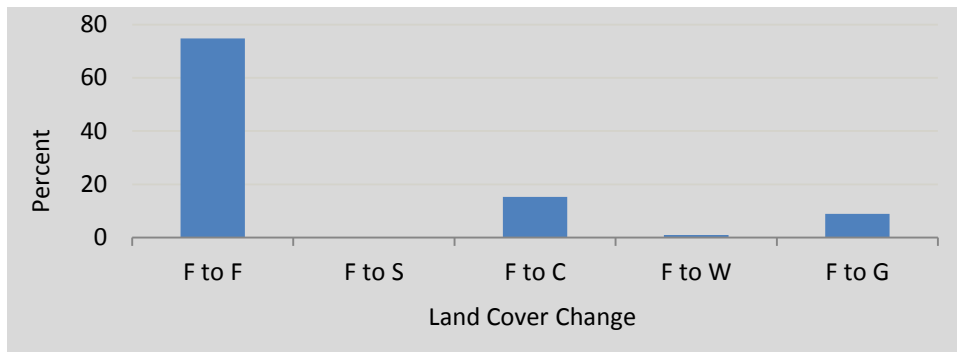
Figure 14 Forest Cover Change in the Study Area, 1990 – 2010

The expansion of existing settlement coupled with the formation of new ones subsumed the least (0.1 percent) proportion of forestlands. However, in assessing holistically, the impact of settlements formation, growth and expansion on the ecosystem, it is important to factor the impact of the activities of the people that make up the settlements. Thus, the high increase in crop and grass lands at the expense of forestlands is highly related to that seemingly small increase in settlement cover.

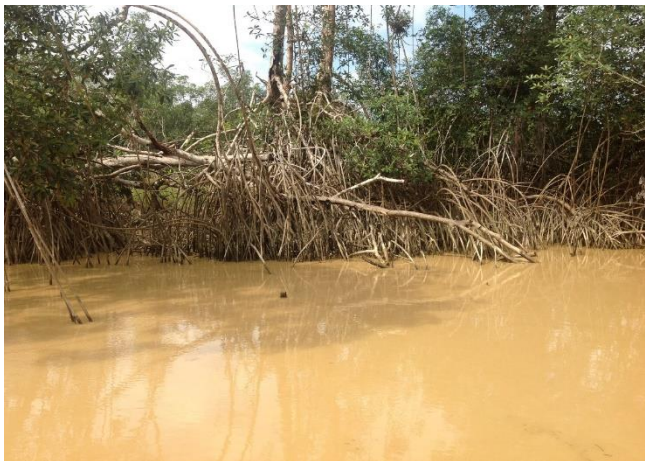
Affirming the alarming depletion of forest and wetlands from the land cover analysis, evidence of massive logging of mangroves and bamboo in the estuary was observed.

Plate 7 Depleted Mangroves

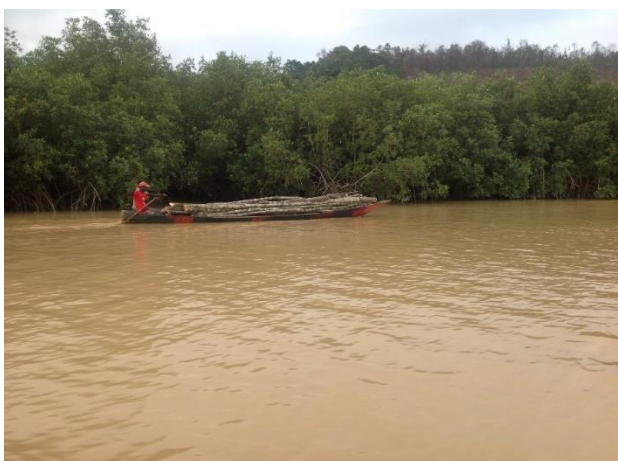
Plate 8 Illegally Logged Mangroves being transported

Illegal logging particularly the destruction of mangroves for both construction and domestic uses have directly and adversely impacted fish stock and livelihoods of people in the area. Development of settlements and other human activities including unorthodox cutting of bamboo have degraded the riparian lands along the river.

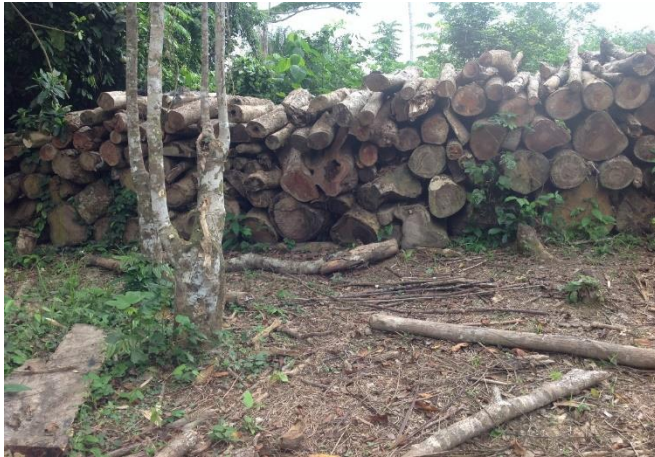
Plate 9 Illegally Logged Mangroves

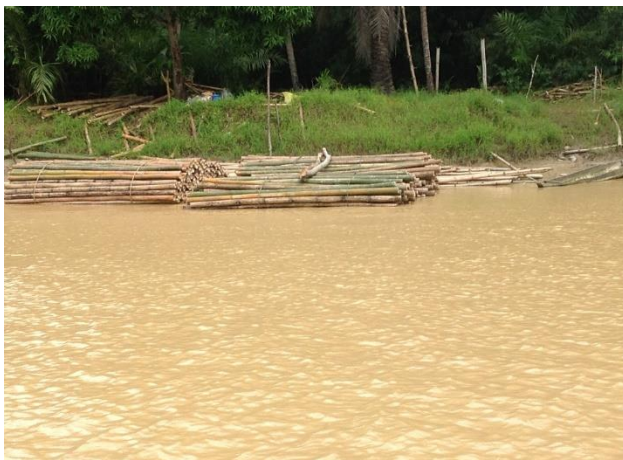
Plate 10 Illegally Cut Bamboos awaiting Transportation

Bamboo cutting is one of the major activities that take place at the edge of the river as shown by plate 10. Though bamboo cutting is not to be discouraged completely - as it generates livelihoods for the communities, the methods employed for cutting are destructive and unsustainable. The clear cut method is usually adopted leading to complete destruction of most of the bamboo concentrated areas along the River. Bamboo cutting causes intense destruction to the ecosystem by the impact that they create on flora and fauna and also the on damages caused to riparian lands. The bamboo that are of no commercial value are set ablaze after they are dried causing bushfire and severely destroying the marine ecosystem.

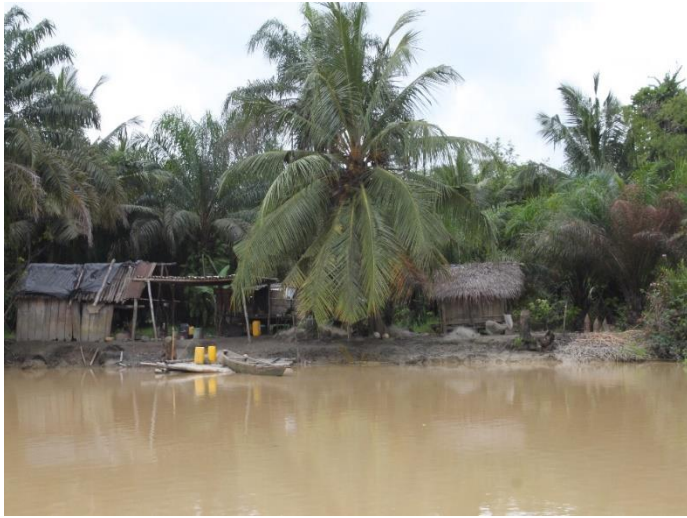
Plate 11 Emerging Settlement at Ankobra River Bank

The basin is currently experiencing new sporadic settlement development along the river banks with all kinds of human activities taking place (see plate 11). Intensive palm wine tapping which eventually are brewed into liquor has become a major activity driving these settlements development and all these are occurring on riparian lands. The extent of pollution

caused by these human activities though cannot be quantified. One can deduce that in the absence of proper sanitation in these newly developing settlements, most of the waste emanating from these communities will eventually end up in the sea.

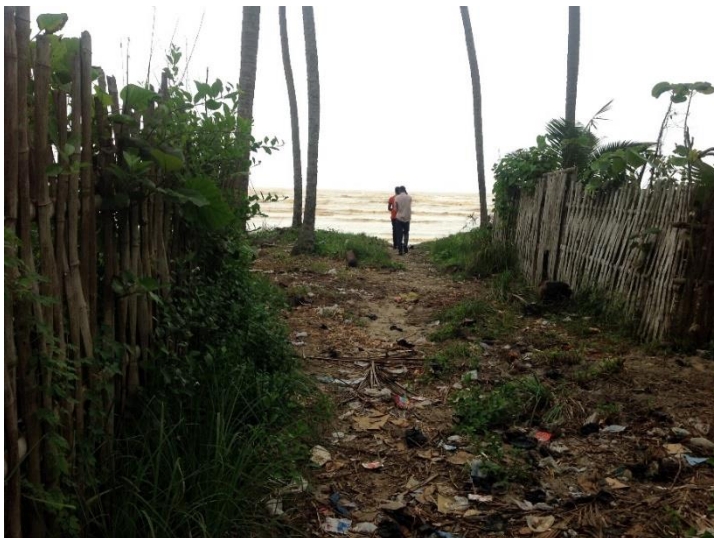
Plate 12 Insanitary Condition at River Bank

Sanitary facilities are not available in most communities and where they are provided the conditions are quite poor. Settlements like Adrekazo which close to the river dump most of their refuse into the Ankobra River and these are drained into the sea. Sanwoma, the largest community in the area uses both the river and sea as their dump sites. The health implication from the pollution can create problem for the community and certainly for the marine ecosystem.

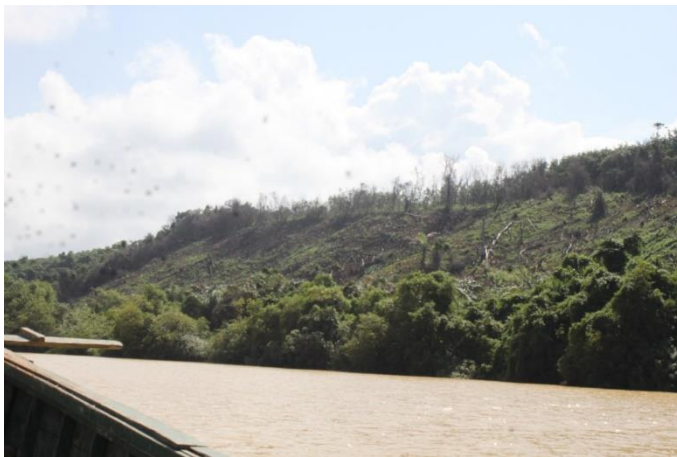
Plate 13 Land Cleared for Rubber Plantation

Large tract of land has been cleared for rubber plantation farming close to the river banks. There are also a few tracts of cocoa and oil palm plantations in the same area. These farming activities are extensively influenced by companies like GREL and Norpalm who provide credit facilities to out-growers. This partly accounts for the rapid growth of croplands and grassland observed under the land cover analysis. Until the rubber trees are matured, the effect on the ecosystem is quite high as previous virgin forest will be lost till seven years when the rubber would mature.

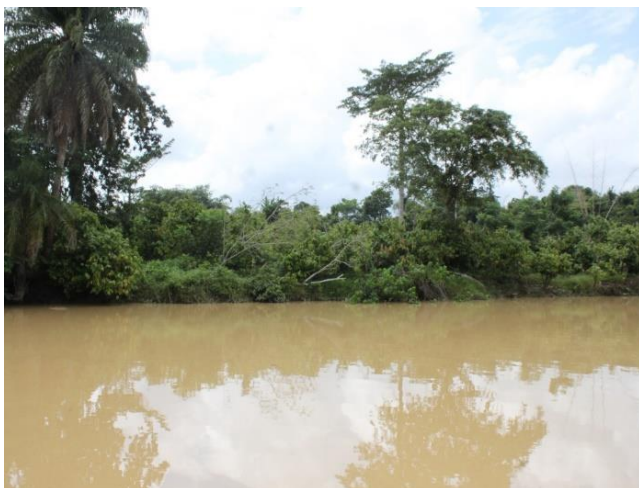
A report from a study conducted by the WRC indicates that the amount of arsenic transported by the river in 2006 were 18,000 kg/ year. High levels of cyanide in the river were reported in the WRC report cited above. Therefore, one of the major challenges in the Ankobra River Basin is the impact of mining activities on the quality of the surface water of the basin. Even from the layperson’s point of view the Ankobra River particularly the southern coastal part is highly polluted and with the increase amount of mining, legal and illegal, the arsenic levels would have tripled between 2006 and 2015.

Plate 14 Polluted River Ankobra

Degradation of the water quality of River Ankobra as indicated in the figure poses series of threats. The increased turbidity, arsenic loads from old mine dumps and exposure of arsenic bearing rocks from the activities of the mining operations as well as accidental spillages from the mines are a threat to the quality of the surface water and pose a major threat to fishes.

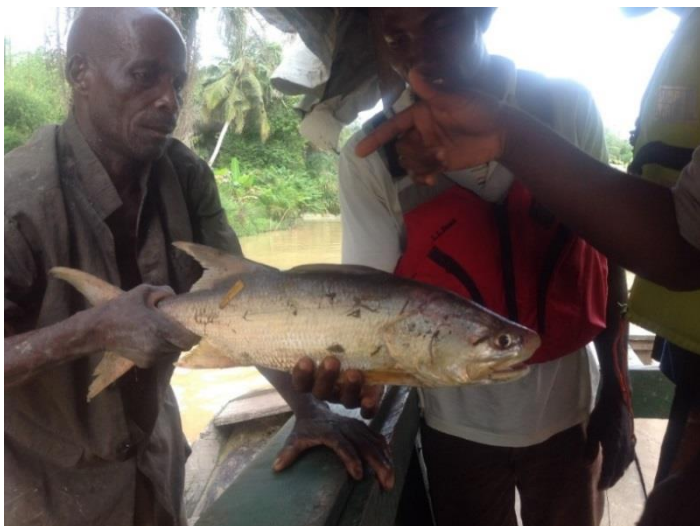
Plate 15 Fish breed now rare in the Ankobra River

From field observation it is mainly mangroves that dominates in the area is classified as forest followed by bamboos. By using mangroves as a proxy for forest, the intense depletion of mangrove for construction and as firewood for smoking fish has a direct bearing on the depletion of demersal fish stock. From field interviews certain types of fish breed as seen in plate 15 that were in abundance 10 to 15 years ago are now becoming rare breed.

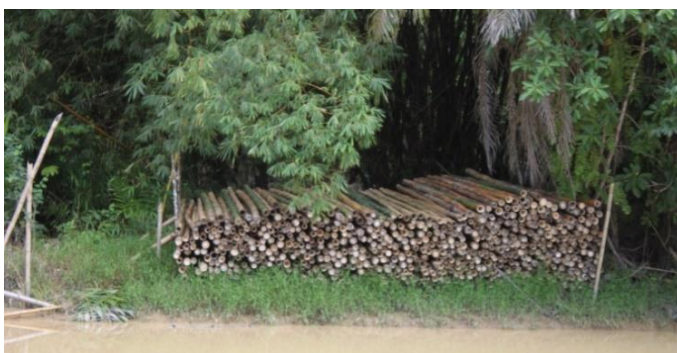
Bamboo Piled for Transport

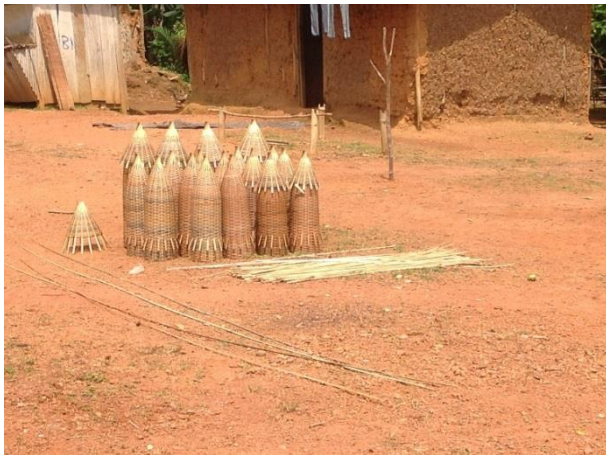
Traps for crustaceans

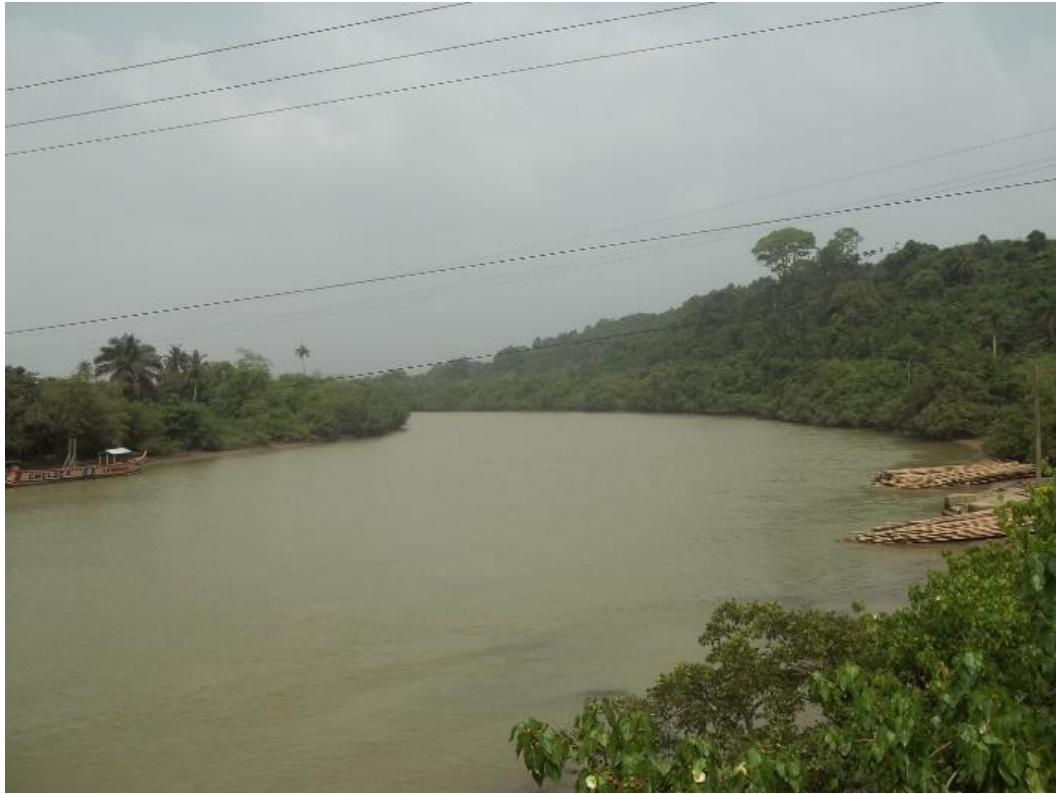
Ankobra in September 2012

See changes in the ecosystem of the Ankobra caused by farming and other human activities between 2012 and 2015 in appendix 4.

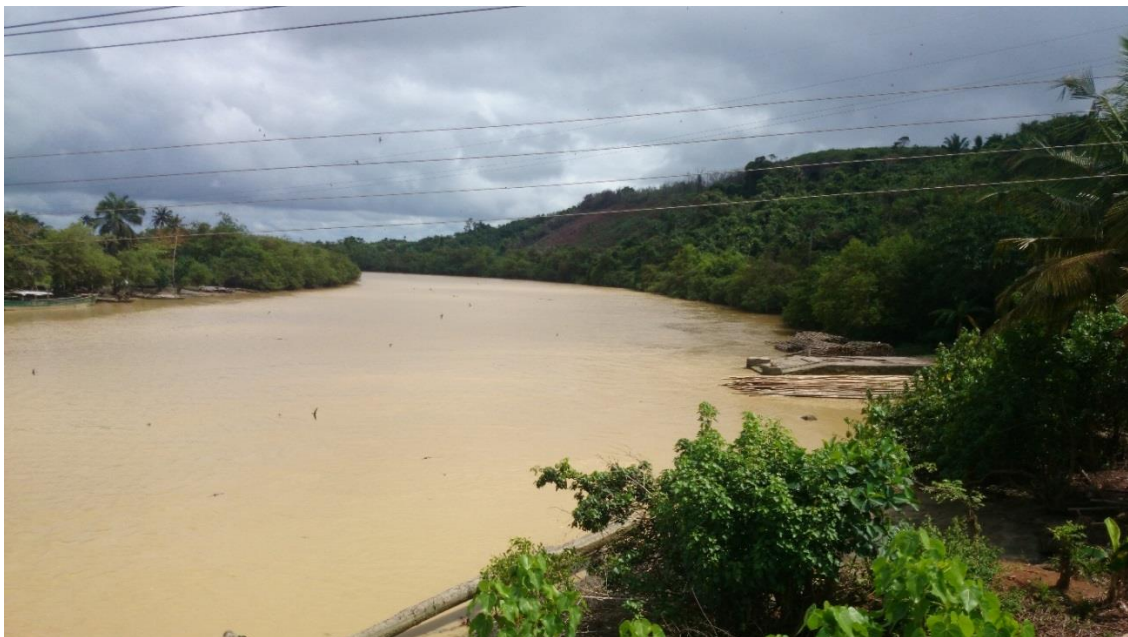
Ankobra in October 2015

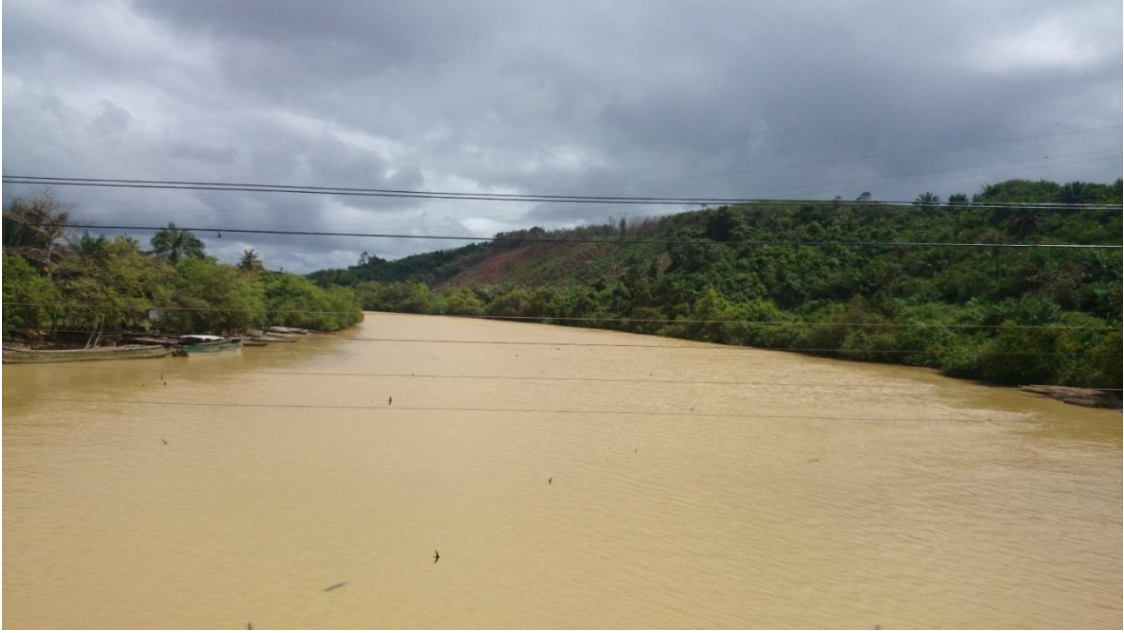
Ankobra in October 2015 – note change in water color and vegetative cover

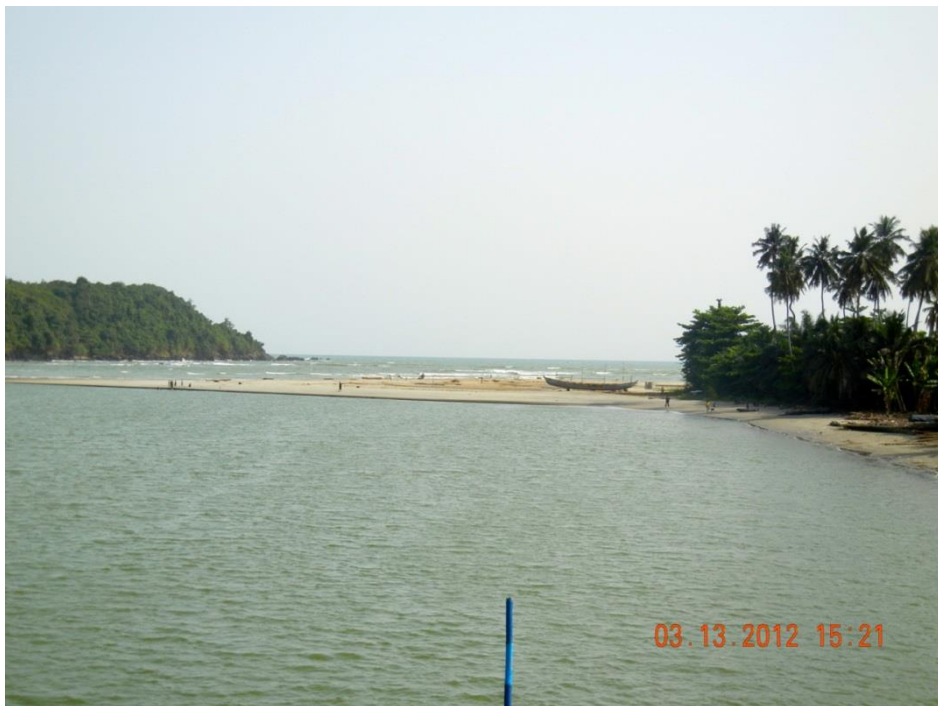
Ankobra Estuary 2012

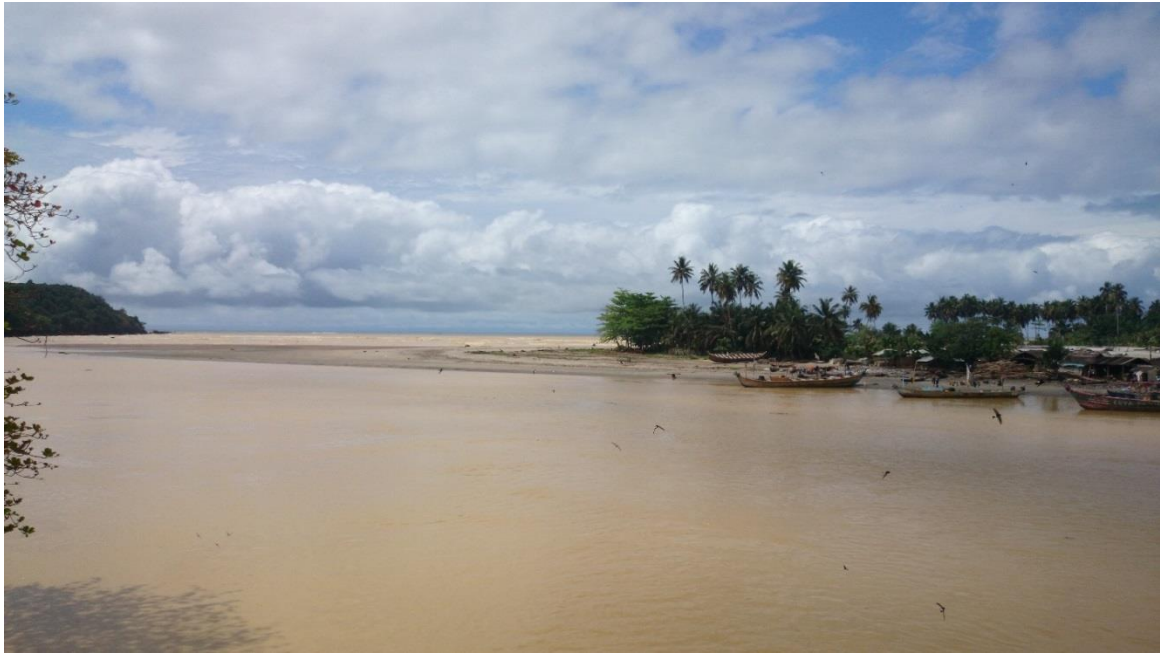
Ankobra Estuary 2015
